Morphological and Temporal Dynamics of Gully Erosion at Abelasta Watershed, Sekela Woreda, Ethiopia

**MORPHOLOGICAL AND TEMPORAL DYNAMICS OF GULLY EROSION AT ABELASTA
WATERSHED, SEKELA WOREDA, ETHIOPIA**

M.Sc. Thesis

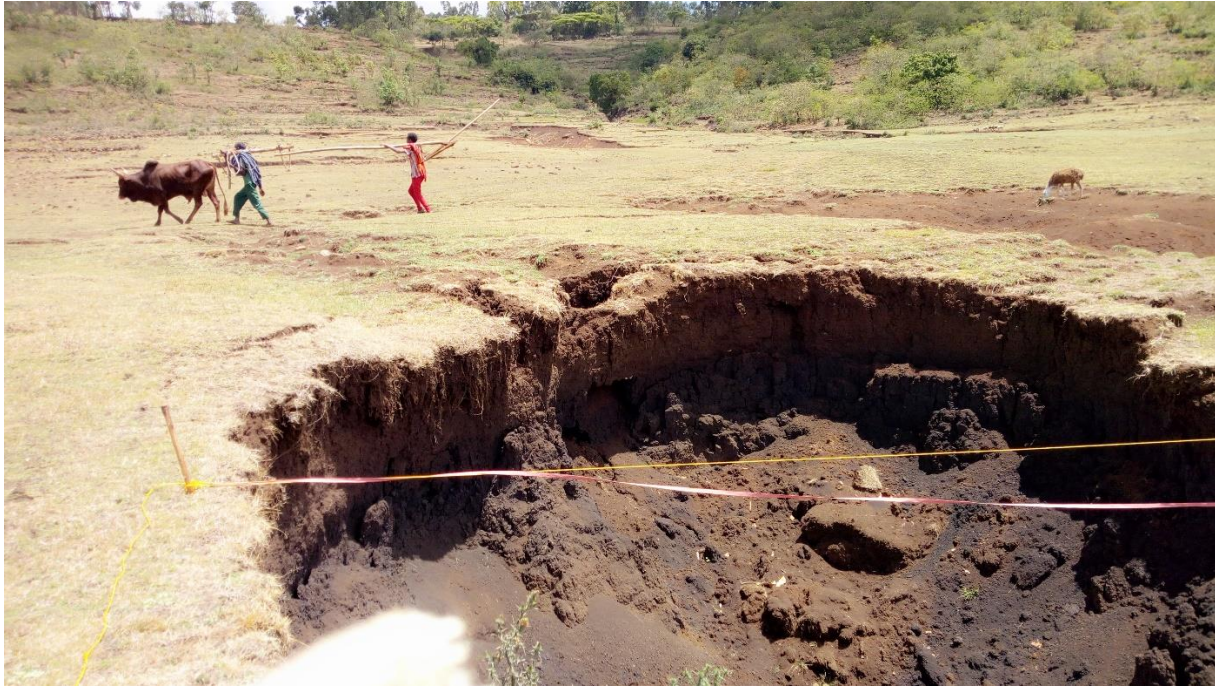
Figure 3. 2. The degradation of study watershed

The study watershed was highly damaged due to gully erosion. The gullies damaged streets, grazing land and in some extent farm lands. On the damaged area, societies used for different cultural and spritual activities like horse riding, xmass day playing and others before.

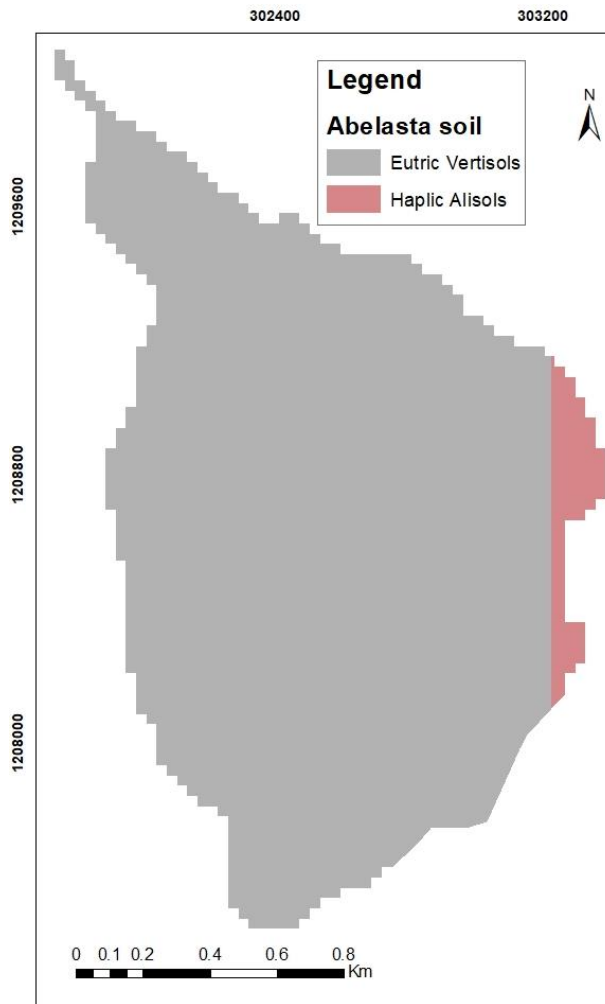
Figure 3. 3. Major soil types in the study watershed

According to Shawul (2005), the study area had two major soil types. These were Eutric Vertisol that covered 229.36 ha (96.35%) area and Alisol that covered 8.68 ha (3.65%); the soil texture was clay and clay loam to sandy clay. The internal drainage was imperfect and well drained.

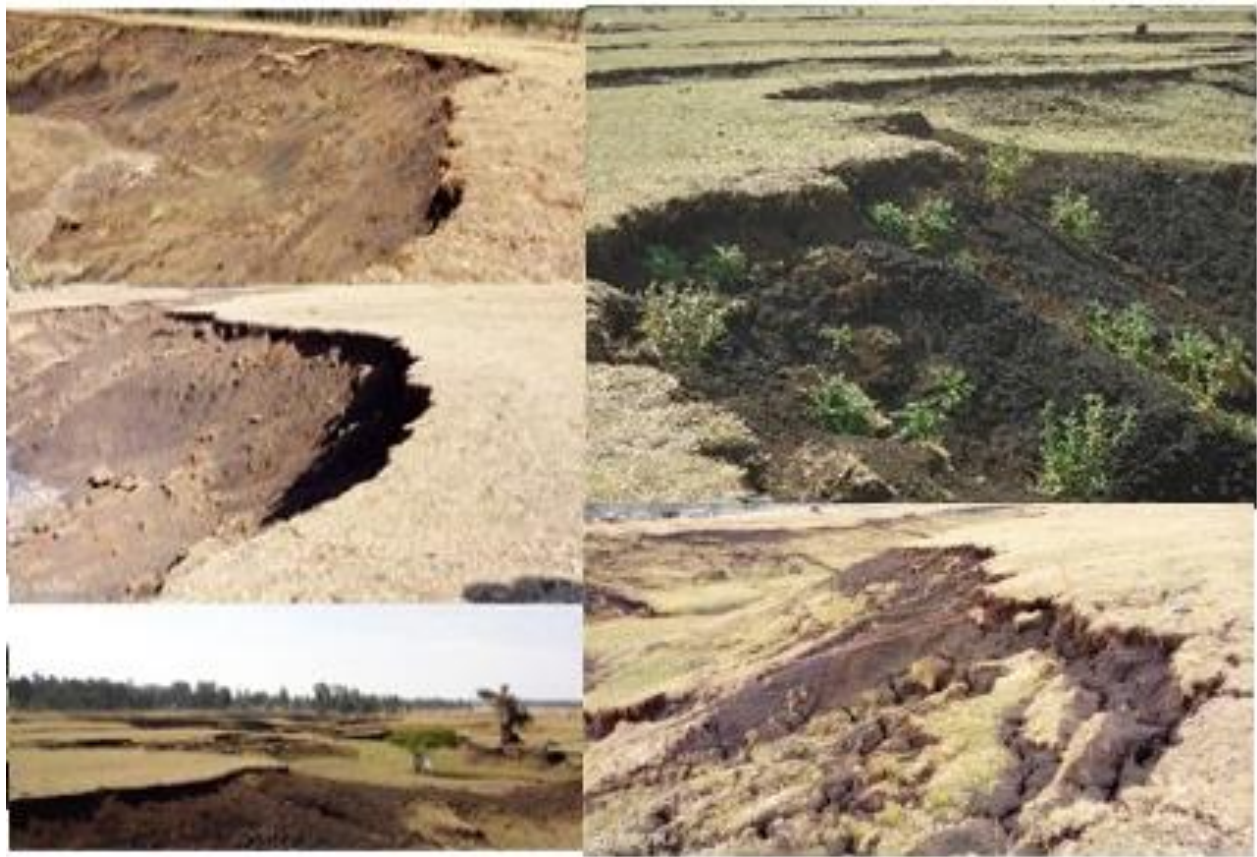
Figure 4. 3. Different gullies photos of the study area

Gully morphology description was started from gully length (Table 4.3). The length of gully 1, gully 2, gully 3, gully 4, gully 5 and gully 6 was 958, 673.2, 270, 375, 1037 and 956 meters respectively. Here, gully 5 was the longest, gully 1 was the second longest and Gully 3 was the shortest. On Dembia district, the highest gully length (2,400 m) and highest lower width (6m) were observed (Addis *et al.*, 2015). Based on depth the size of gully 1, gully 2 and gully 4 were large at most lengths. Gully 3 was medium in all parts. Gully 5 and gully 6 were medium at most parts.

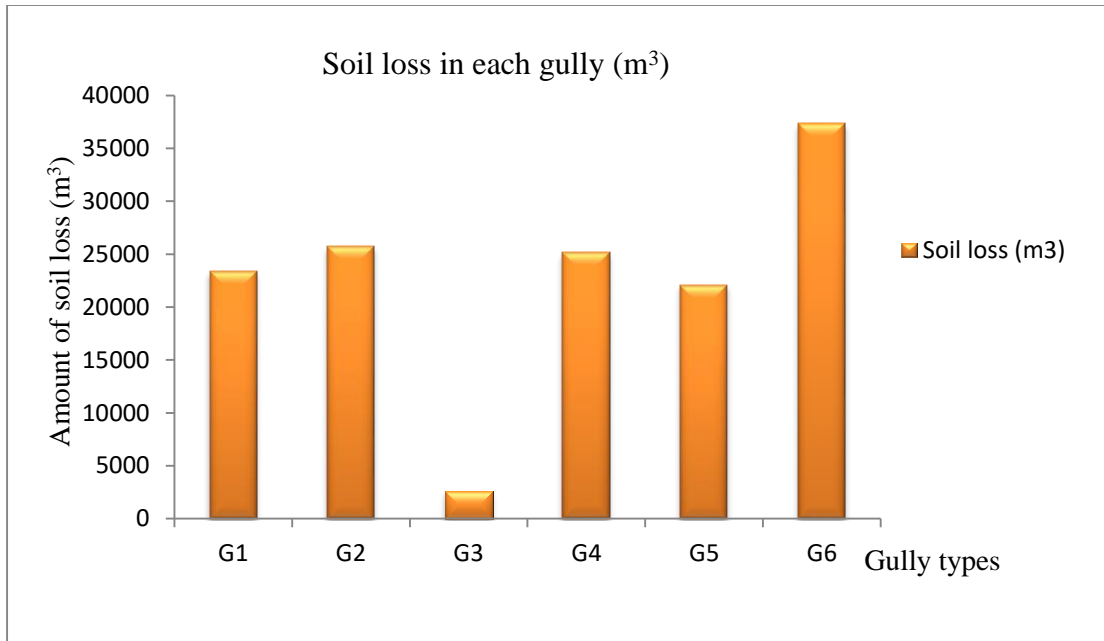
Figure 4. 4. Soil loss in Abelasta watershed

In Abelasta watershed at the lower part (grazing area) was the most degraded and eroded area. The degradation was due to gully erosion. Each gully impact was quantified and calculated based on field measurement (Table 4.5 and Figure 4.4). At G1, 23331.48 m³ soil was lost which was 119.39 ton ha⁻¹yr⁻¹; at G2, 25729.78 m³ which was 141.43 ton ha⁻¹yr⁻¹ soil was lost. Additionally, at G3, 2634.15 m³ in which 14.84 ton ha⁻¹yr⁻¹ soil was lost; at G4, 25140.3 m³ (130.09 ton ha⁻¹yr⁻¹) soil was lost. Further at G5, 22077.2 m³ in which 135.82 ton ha⁻¹yr⁻¹ and at G6, 37358.93 m³(216.83 ton ha⁻¹yr⁻¹) soil was lost.

Finally, total soil loss due to gully erosion in the watershed was 133,637.68 m³ (758.37 ton ha⁻¹yr⁻¹) . In the Genbo Wonz Watershed, north-west highlands of Ethiopia, the annual rate of gully erosion was found to be 62 t ha⁻¹ (Yazie *et al.*, 2020).
